Mount Hollowback 2.4GHz Investigations

August 2-4 2019

Summary Observations

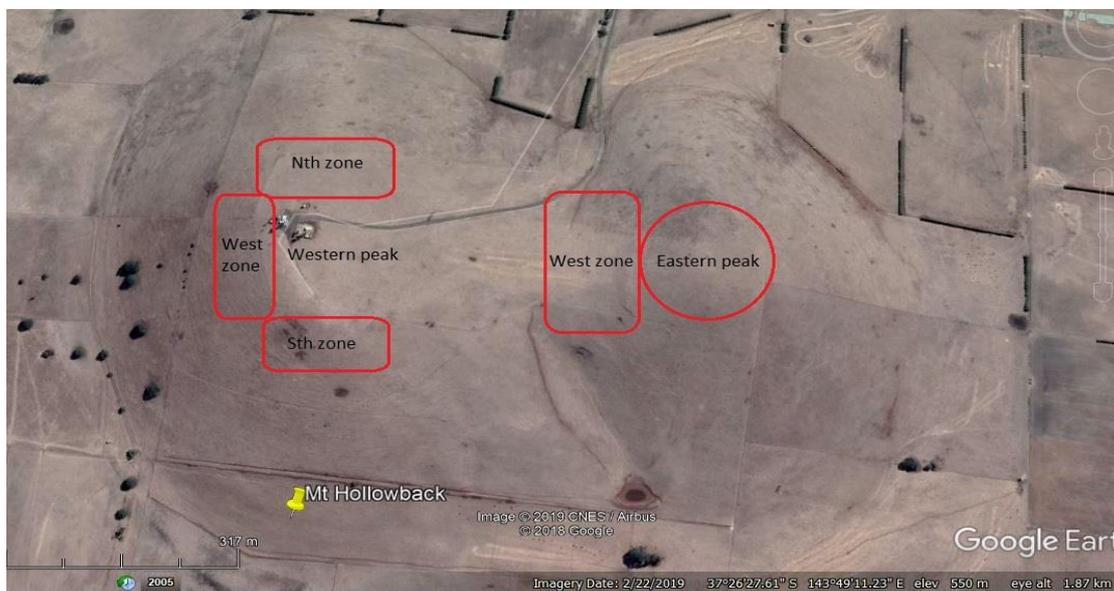
Areas covered by Test Flights

Failsafe triggering was observed when flying on the Western peak from SW to NW, and NNE to E. The most prolonged failsafe events were from the SW to NW. Failsafe events were more apparent when flying at approximately half the average tower height.

Use of the electric motor, which was required for flights over downwind areas and when wind was insufficient for slope lift, may have resulted in slightly increased failsafe triggering.

With the current, and most likely increasing level of background noise, the use of 2.4GHz equipment is NOT recommended for use at Mount Hollowback.

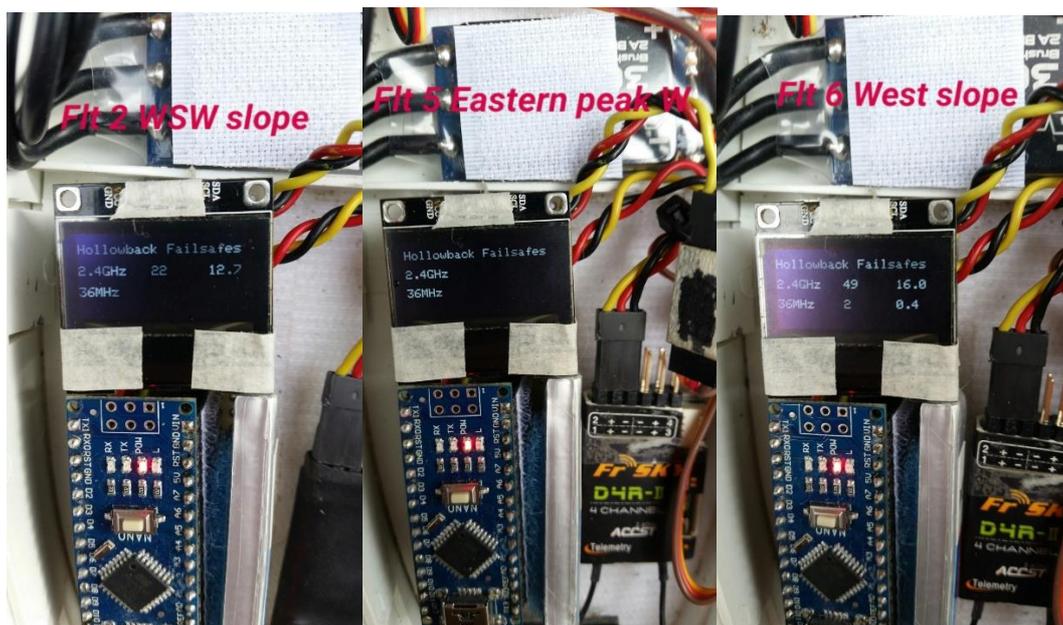
Flight logger displays showing the number of hits and maximum duration

Failsafe hits – 2.4GHz 17, Max duration **13.6 Sec.**

Failsafe hits – 2.4GHz 22, Max duration **12.7 Sec.**

Failsafe hits – 2.4GHz 14, Max duration **6.3 Sec.**

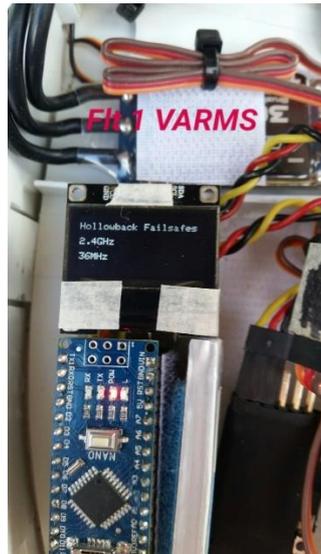
Reference Flight at VARMS Field

For completeness a 10 minute reference flight was conducted at VARMS Field, High Street Road, Wantirna, 3pm on the 5th August 2019. The flight extended from the SW corner to the NW corner and generally over the field.

There were no hits on 2.4GHz or 36MHz. The noise floor was -80dBm.
