36MHz Studies

14, 26 & 29 August 2019

Summary Observations

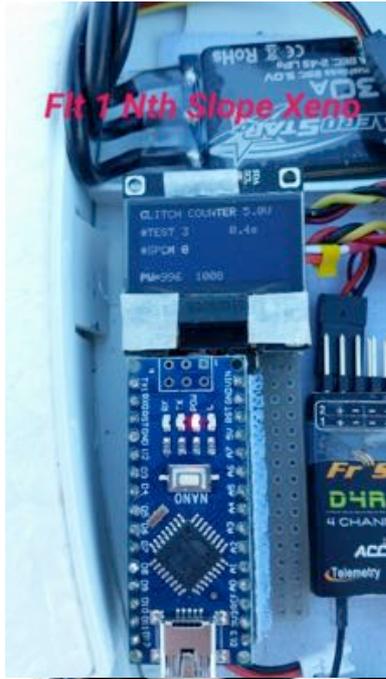
Fit 1 Nth Slope Xeno

PPM 36.43MHz Glitch hits – 3, Max duration **0.4 Sec.**

SPCM 36.17MHz Failsafe hits – 0, Max duration **0 Sec.**

This was mostly a gliding flight with some short bursts of motor assist. Altitude ranged from launch height to 200 feet. There was a good period of time spent flying over the North East landing area, as well as in front of the towers. This was downwind of the pilot, with the altitude ranging from low to ½ tower height. There was also an excursion of flight out to the North to approx. 150 metres from the pilot's position. 2 Glitch hits were recorded during motor run periods and the other during glide. These would not be considered a problem. As a note, the turbulence in this wind strength was considered to more of a problem.

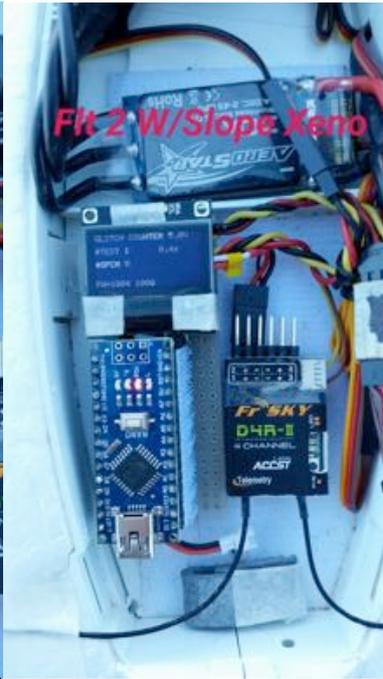
Fit 2 W/Slope Xeno

PPM 36.43MHz Glitch hits – 1, Max duration **0.4 Sec.**

SPCM 36.17MHz Failsafe hits – 0, Max duration **0 Sec.**

This flight was all motor assisted and difficult to achieve due to wind direction and strength (and turbulence!) The idea was to fly over the western slope area as would be done in a normal slope soaring flight. As said, this was difficult to achieve, however, there were multiple passes close in and in front of the towers, also over the power lines. The single glitch occurred on the North Slope while the pilot was walking back to get into position to fly the western zone.

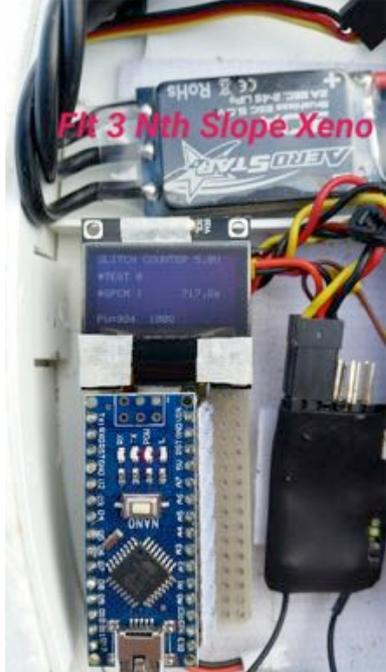
Fit 3 Nth Slope Xeno

2.4GHz Failsafe hits – 0, Max duration **0 Sec.**

SPCM 36.17MHz Failsafe hits – 1, Max duration **717.8 Sec.**

This flight was a re-test of the 2.4GHz failsafe problems as experienced on the weekend of 2 – 4 August 2019. The flight profile was at 1/2 tower height over the North East landing zone to the North West corner of the hill and in front of towers. As such, part of the flight was motor assisted. The zero failsafe count highlighted what many have said, that they have flown on days without issues and then the next time

out resulted in a crashed model. It is hard to know what packet data traffic is being sent from the towers at any given time. The Failsafe hit on SPCM was the result of knocking the gear switch (to the high position) on takeoff, which was not noticed until after the landing.

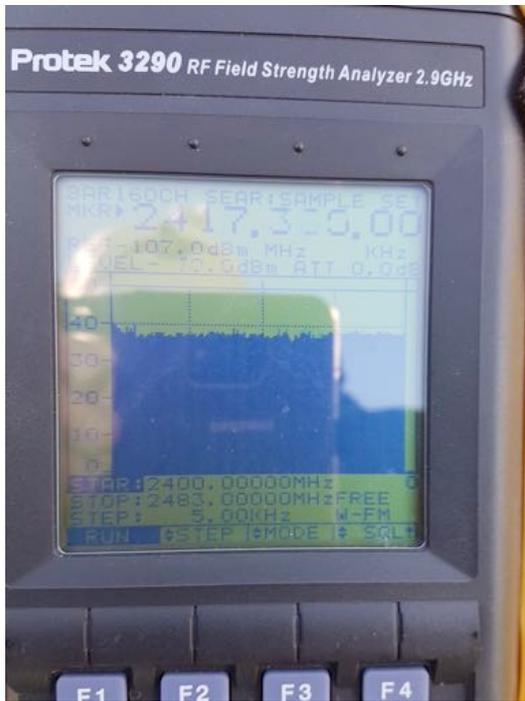
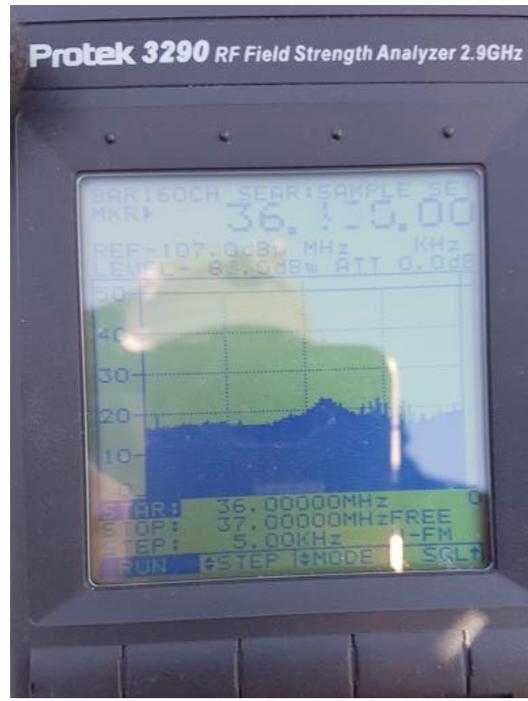
The noise floor within 20 metres of the towers was observed as -86dBm @ 36MHz and -70dBm @ 2.4GHz. Higher fluctuations of 2.4GHz were noted in relatively short bursts.

Close to the flight line on the Northern Slope it was -90dBm @ 36MHz and

60dBm @ 2.4GHz. Note that the noise floor was higher on the slope for 2.4GHz, most likely due to catching one of those transient fluctuations noted above.

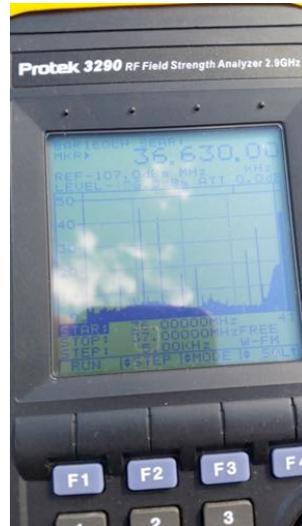
At the time of measurement, no model aircraft transmitters were active. The 36MHz noise floor at -102dBm is considerably lower than that measured at Mount Hollowback. Strong signals can be observed on various frequencies however. The scan set on the instrument of 36.0MHz to 37MHz was double the frequency allocation for model aircraft so signals in the second half of the screen can be discounted.

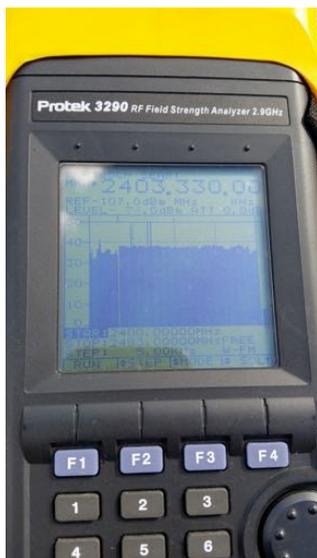
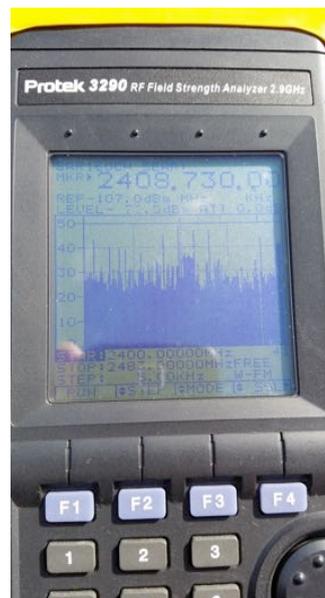
The sample scans on 2.4GHz show the noise floor at a high level of -74dBm to -72.5dBm. Some models were flying at the time, with the Signal Analyser only about 15M away. The higher spikes will be due to the model transmitters, but clearly other

signals are present also. This demonstrates the very clever nature of frequency hopping technology. Unlike Mount Hollowback, there are no high powered services nearby and certainly not on 2.3GHz. (NBN allocation on Mount Hollowback).

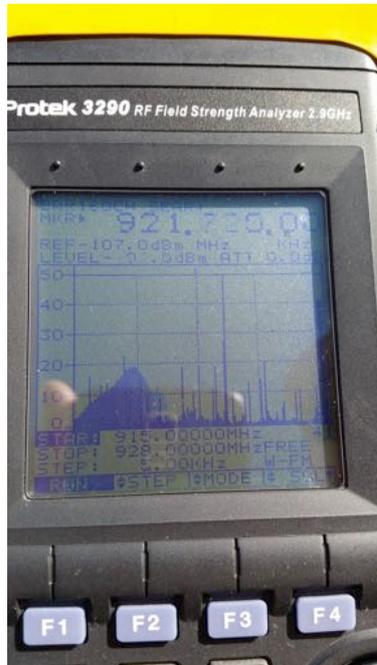
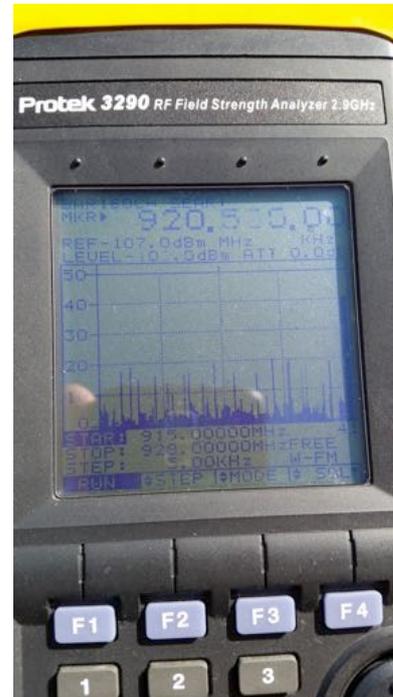
915 – 928MHz

A number of signals were noted on this frequency band, but with a noise floor at a very low level of -97dBm to -101dBm. The average signal level is also low and would not present a problem to locally controlled models on this frequency.
