36MHz Studies

14, 26 & 29 August 2019

Summary Observations

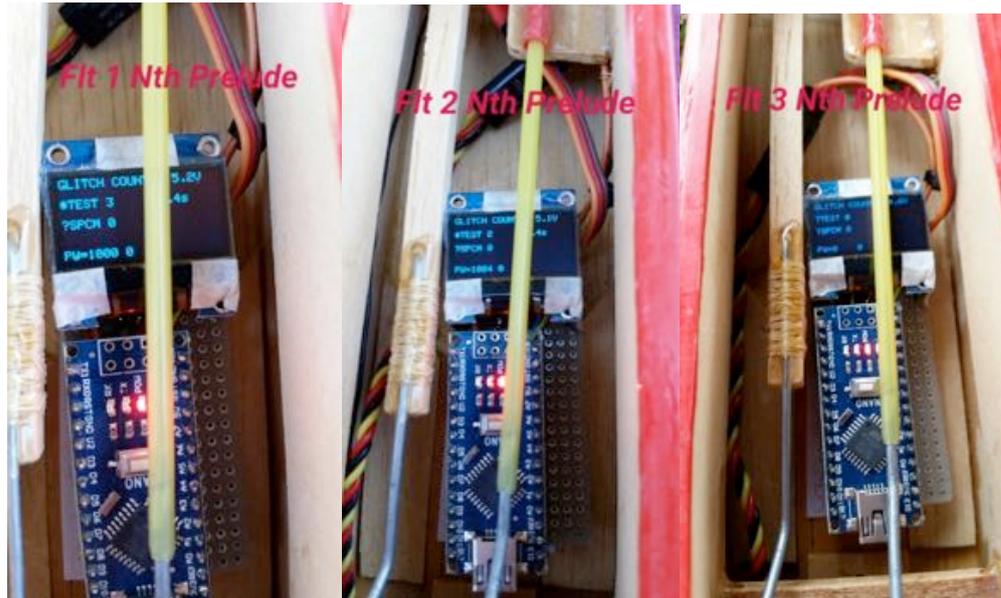
The receiver was change out for the JR NER-326X, together with a frequency change to 36.17MHz.

A repeat of flight 2 - a gliding flight in turbulent conditions over the North Slope. A zero glitch count may indicate that this receiver had a better “mute” than the R700.

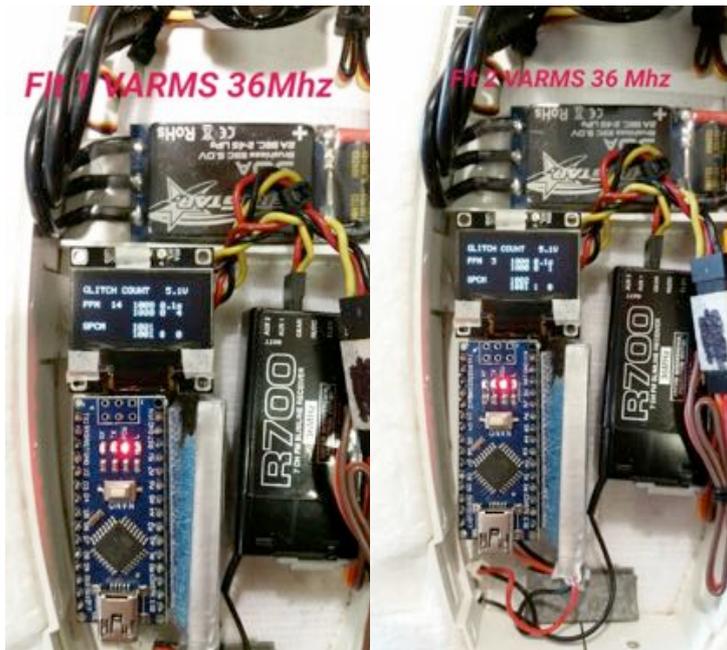
Flight 2 - 14 Aug 2019 between 2 – 3 pm, wind NNW 5 to 10 knots
 Zone flown – W to NW corner and general over field
 Pilot location – Pilot box
 Flight duration – 3.5 minutes
 Glitches – 36.43MHz PPM **3**, Max duration **.1 sec.**
 Failsafe hits – 36.17MHz SPCM 0, Max duration **0 sec.**

This was a climb and glide flight. 50 sec of motor run then glide down. The lower glitch count indicated the ESC and motor generate some noise, elevating the on-board general noise floor. Altitude roughly 350’.

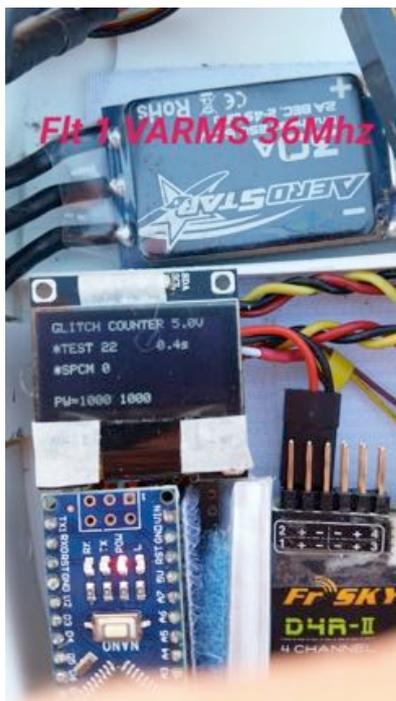
Flight 1 - 26 Aug 2019 between 2 – 3 pm, wind SW 1 to 4 knots
 Zone flown – SW corner to NW corner and general over field
 Pilot location – Pilot box
 Flight duration – 11 minutes
 Glitches – 36.43MHz PPM 22, Max duration .4 sec.
 Failsafe hits – 36.17MHz SPCM 0, Max duration 0 sec.

Flight was mostly under power with approx. 2 minutes of gliding. Various throttle settings from low to full power. Altitude low to 400'. Multiple flyby passes over landing strip.
